Item No.41. DELETION OF STEERING ROD COVER (PART NO.50570)
- ALL MODELS.

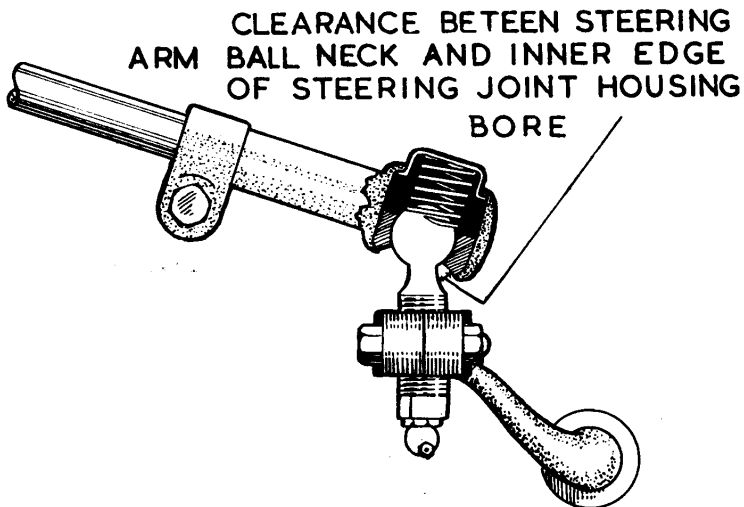
steering ball housing and the neck of the steering ball are in contact. In this case, IMMEDIATE ACTION must be taken to fit replacement ball joint assemblies as detailed in Bulletin Item No.30.
