## Item No.64. CAMSHAFT KNOCK - JAVELIN &amp; JUPITER MODELS.

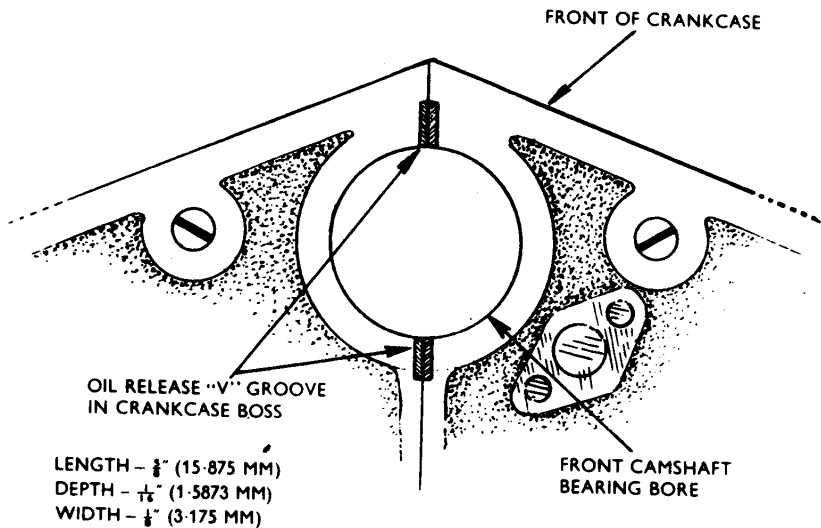
Instances of heavy intermittent engine knock, particularly at slow running speeds, have been traced to camshaft end float.

Investigation has indicated that this is due to oil pressure building up between the camshaft boss and the crankcase, thereby causing a "hydraulic" action.

We have recently introduced a modification in the form of a groove in the crankcase bearing boss to relieve excess pressure at the point as illustrated in the sketch below.

Camshaft end float is normally controlled by the thrust spring, Part No. 50681, but when any knocking of the nature referred to is experienced, the following action should be taken:-

1. Increase the tension of the thrust spring.  
A simple check may be effected by tapping
